Manhole Inspection Summary

Manhole # S37S__033MH

Insp Date: **1/25/08 9:27 AM**

Location Address: **e.gittings st**

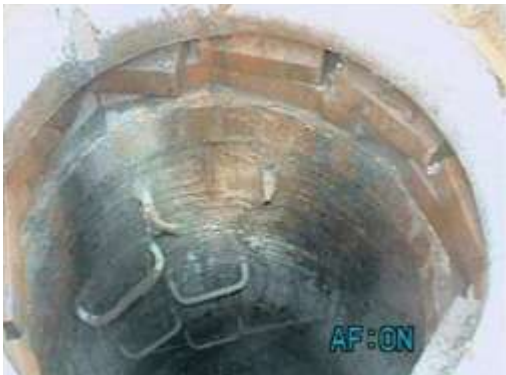
Defect 2

Condition: ☐ Sound ☐ Cracked ☐ Root Intrusion ☒ **Loose Brick** ☐ Deteriorated

Infiltration: ☐ None ☒ **Joint** ☐ Cracks ☐ Mortar ☐ Roots ☐ Wall

Steps Count: **5** Missing: **1** ☐ Corroded

loose bricks in chimney and corbel, joint infiltration evidence, and missing step

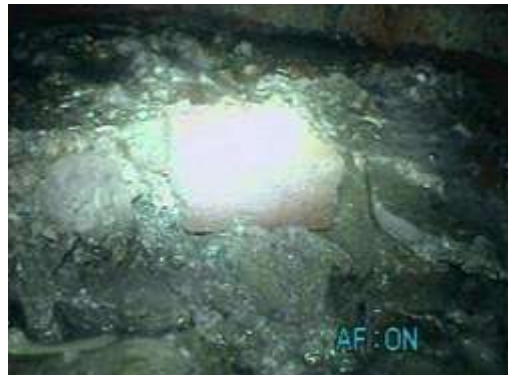
Defect 1

Condition: ☐ Sound ☐ Cracked ☐ Root Intrusion ☒ **Deteriorated** ☐ Leaks ☒ **Debris**

Condition: ☐ Sound ☐ Cracked ☐ Root Intrusion ☒ **Deteriorated** ☒ **Leaks** ☒ **Debris**

bench and channel debris, bench and channel deteriorated

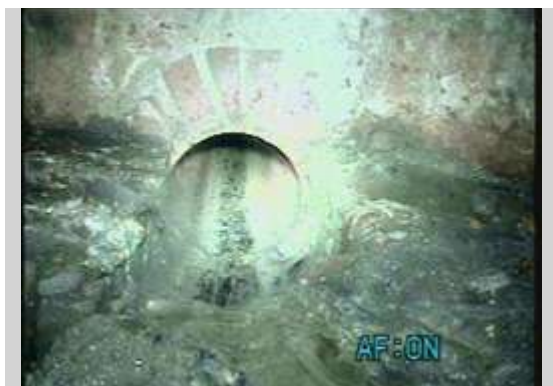
12 O'Clock Outflow

8 in. Circular Gravity Sewer
Pipe Out @ 12 O'Clock
